DEPARTMENT OF TRANSPORTATION**DIVISION OF ENGINEERING SERVICES**

Contract #: 04-0120F4Cty: SF/ALA Rte: 80 PM: 13.2/13.9File #: 1.28**WELDING INSPECTION REPORT****Resident Engineer:**Siegenthaler, Peter**Address:** 333 Burma Road**City:** Oakland, CA 94607**Report No:** WIR-017239**Date Inspected:** 01-Oct-2010**Project Name:** SAS Superstructure**OSM Arrival Time:** 630**Prime Contractor:** American Bridge/Fluor Enterprises, a JV**OSM Departure Time:** 1500**Contractor:** American Bridge/Fluor Enterprises, a JV**Location:** Jobsite**CWI Name:** See below**CWI Present:** Yes No**Inspected CWI report:** Yes No N/A**Rod Oven in Use:** Yes No N/A**Electrode to specification:** Yes No N/A**Weld Procedures Followed:** Yes No N/A**Qualified Welders:** Yes No N/A**Verified Joint Fit-up:** Yes No N/A**Approved Drawings:** Yes No N/A**Approved WPS:** Yes No N/A**Delayed / Cancelled:** Yes No N/A**Bridge No:** 34-0006**Component:** SAS OBG**Summary of Items Observed:**

- 1). West Line OBG Field Welding of Diverter Bar and CW Horizontal Lower Lug (SMAW)
- 2). OBG Field Splice 6W/7W weld ID: F1, Face B (SMAW)
- 3). OBG Field Splice 6W/7W weld ID: A1 – A5, Face A (QC UT)
- 4). OBG Field Splice

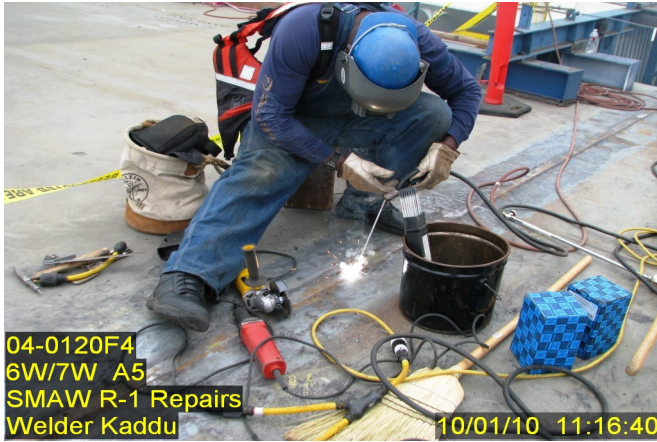
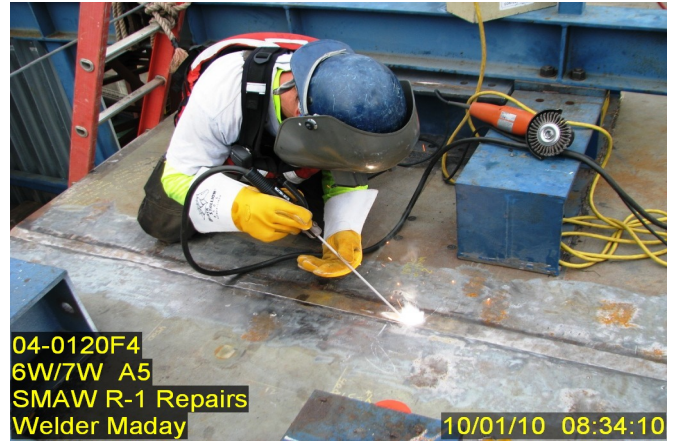
The QAI periodically observed AB/F approved welder Bryce Howell (ID 5591) performing grinding to excavate QC UT R-1 repair areas at OBG Field Splice 6W/7W weld ID: A5, face A. Mr. Howell excavated areas at Y = 820mm and Y = 1470mm. The QAI also periodically observed AB/F approved welder Mike Maday performing grinding to excavate QC UT R-1 repair areas at weld A5 location Y = 3920mm. The QAI periodically observed AB/F approved welder Mike Maday performing repair welding of excavated areas per the SMAW process in the 1G (flat) position at Y locations of 820mm, 1470mm and 3920mm. Later in the shift the QAI periodically observed AB/F approved welder Fred Kaddu (ID 2188) (replacing Mr. Maday) and performing grinding to excavate QC UT R-1 repair areas and performing repair welding of excavated areas per the SMAW process in the 1G (flat) position at Y location of 690mm. The QAI periodically observed QC Inspectors Tom Pasqualone and Jim Cunningham performing Magnetic Particle Testing (MT) of excavated R-1 UT repair areas prior to welding. The QAI observed that the performance and evaluation of the MT appeared to comply with the MT procedure identified as SE-MT-CT-D1.5-101 Rev. 4. The QAI periodically observed QC Inspector Tom Pasqualone and later Jim Cunningham were present to monitor the progress and verify that the welding parameters were within the limits established by the approved welding Procedure Specification (WPS) identified as ABF-WPS-D1.5-1000-Repair. See photos below. Repair welding was in process at this location and the work at this location appeared to be in general compliance with contract documents.
